Effect of surface-applied treatments on the above-ground performance of simulated timber joinery

Summary

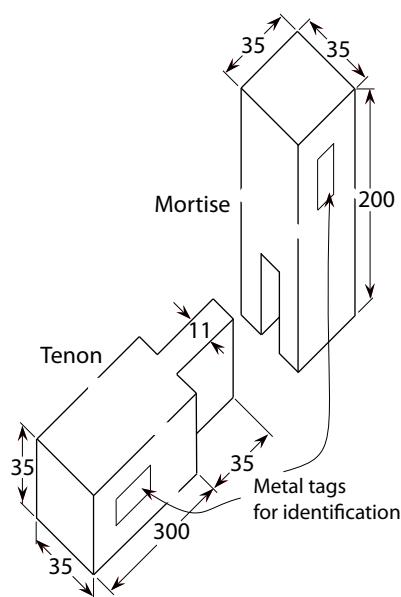
**Figure 1.** L-joint test unit specifications (Cause 1994). All dimensions are in millimetres.

The effect of treatments on each timber species was tested using L-joint exposure specimens. A mortice-and-tenon jointing system was prepared from 35 mm × 35 mm stock and all joints were a machined fit (Fig. 1). The timber species were selected according to their current durability classification (Australian Standard AS 5604-2005) to represent a range of natural durability (Table 2).

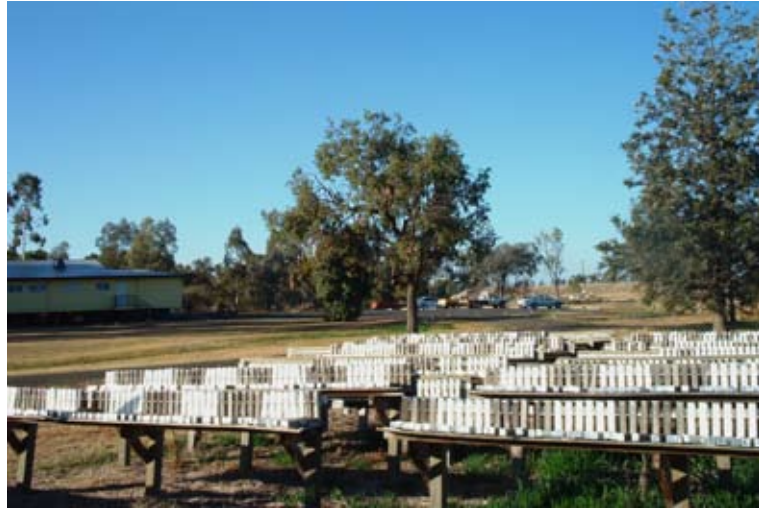
Figure 2. Dalby exposure site

At each site, the L-joint specimens were placed on exposure racks (Fig. 2) constructed from CCA treated plywood and durable framing timbers, about one metre above the ground (Cause 1994). Specimens of each timber species × treatment combination were randomly distributed amongst the racks. Plastic strips and brackets were fixed to the racks to support the L-joint specimens to prevent them from coming into direct contact with the plywood and to provide consistent spacing between each joint. At all sites the racks faced north and were constructed so that, when in position, the L-joint specimens were oriented 10° backward from vertical. The backward slope caused rain or dew to run toward the joint. Each rack had drain holes at the rear to ensure that water did not remain pooled on the rack.
